Inspection Report

Property Address:
111 N. Any Ave.
Aurora IL 60506

Focus Home Inspection LLC

Date: 8/15/2012	Time: 10:00 AM	Report ID: 111111-1
Property: 111 N. Any Ave. Aurora IL 60506	Customer: Sandy Jones	Real Estate Professional:

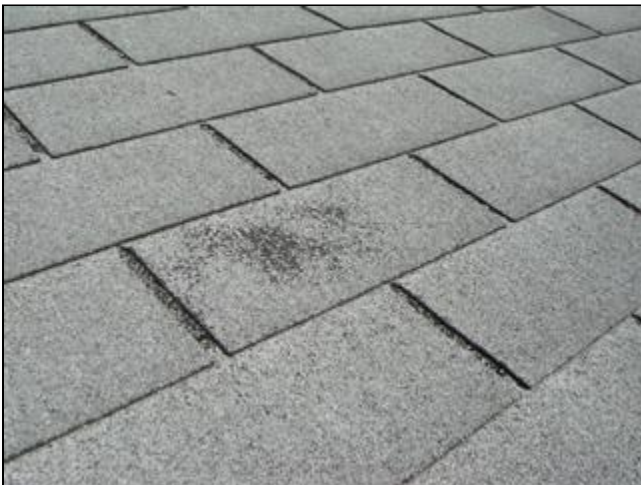
1.0 Picture 1

1.0 Garage roof appears near it's life expectancy.

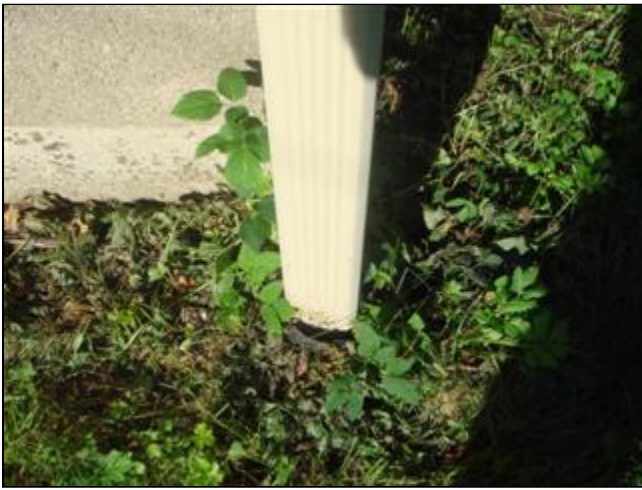
1.3 Picture 1

1.3 (1) Gutters drain underground. Unable to determine how far away from house they drain.

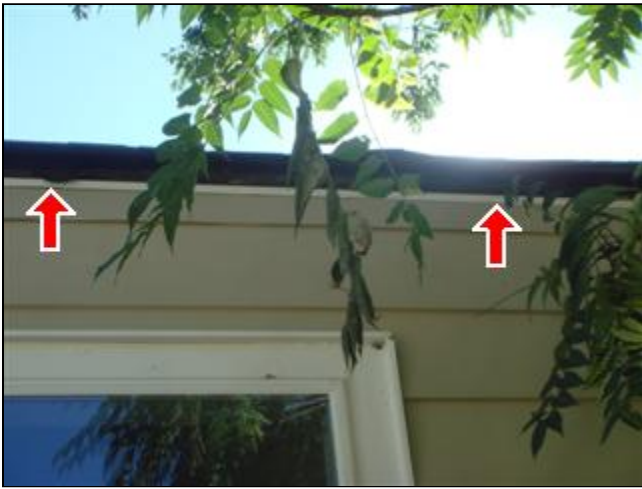
1.3 Picture 2

📍 1.3 (2) Missing gutter on back of house. Recommend repair by a qualified contractor.

(2) Missing gutter on back of house. Recommend repair by a qualified contractor.
-

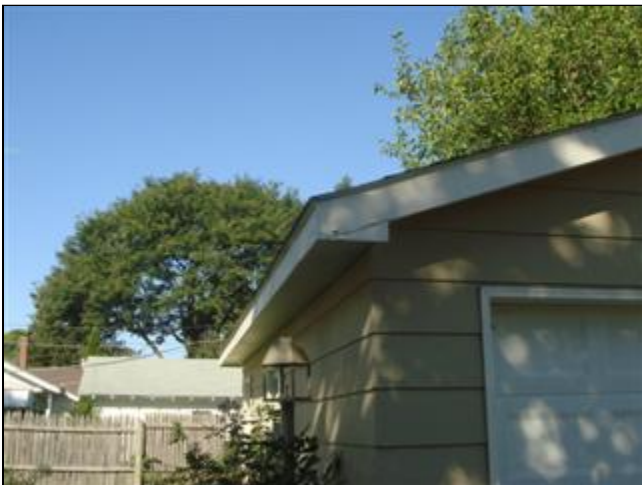
1.3 Picture 3

📍 1.3 (3) Recommend gutters be installed on garage.

(3) Recommend gutters be installed on garage.

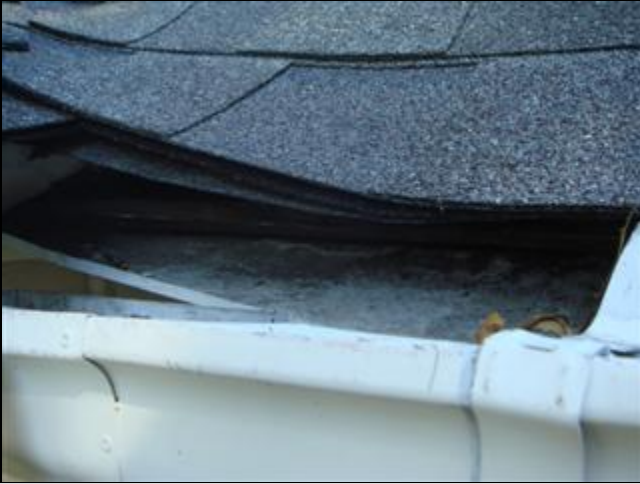
1.4 Picture 1

**1.4** Some rotted wood observed under shingles. Most likely due to poor installation of gutters. Recommend repair by a qualified roofing contractor.

Some rotted wood observed under shingles. Most likely due to poor installation of gutters. Recommend repair by a qualified roofing contractor.

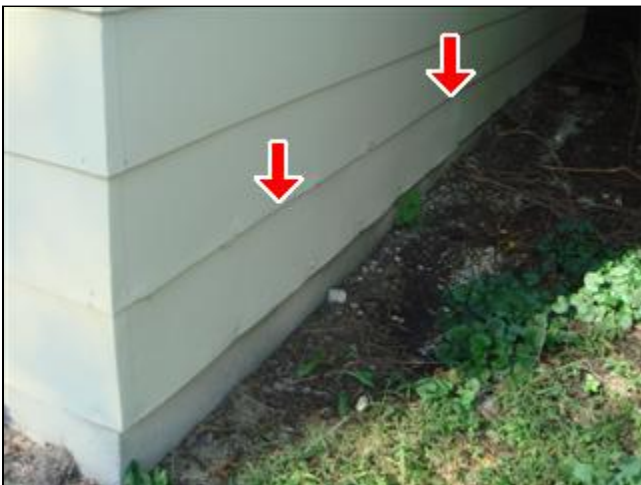
2.0 Picture 1

**2.0** Wood board siding on side of garage is rotting. Recommend repair by a qualified contractor.

Wood board siding on side of garage is rotting. Recommend repair by a qualified contractor.

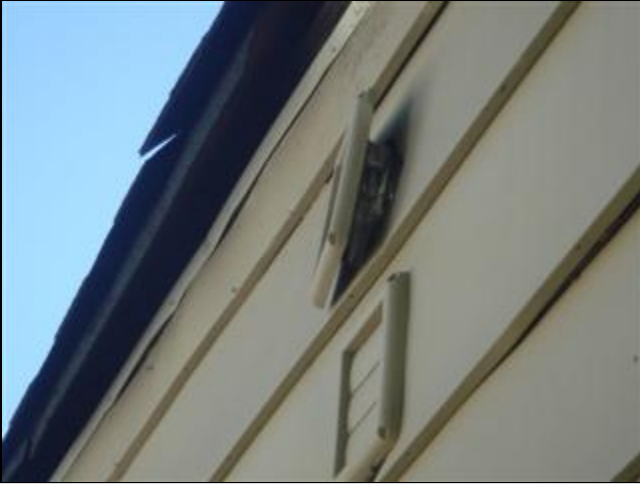
2.1 Picture 1

📍 **2.1** Soffit trim missing from back of house and vent should be installed tight to the house to prevent moisture intrusion. Recommend repair by a qualified siding contractor.

Soffit trim missing from back of house and vent should be installed tight to the house to prevent moisture intrusion. Recommend repair by a qualified siding contractor.

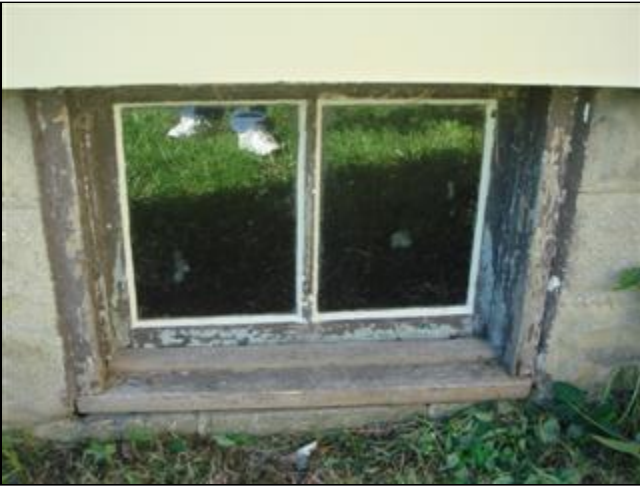
2.3 Picture 1

📍 **2.3** Wood trim on basement window needs to be painted.

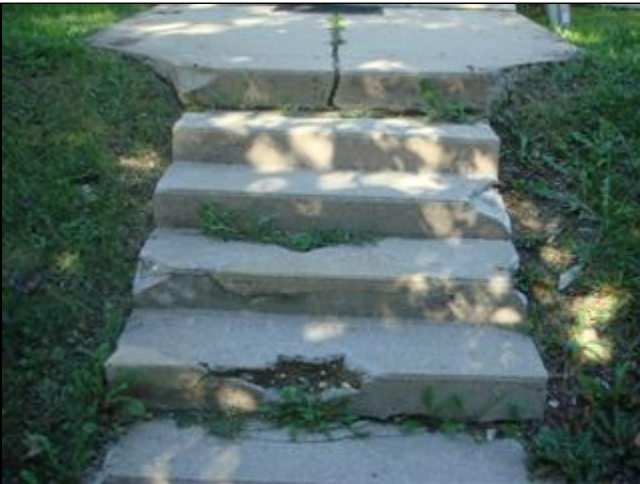
2.4 Picture 1

📍 **2.4** (1) Concrete stairs leading to house are badly deteriorated and lacking handrail. Recommend repair by a qualified contractor.

(1) Concrete stairs leading to house are badly deteriorated and lacking handrail. Recommend repair by a qualified contractor.
-

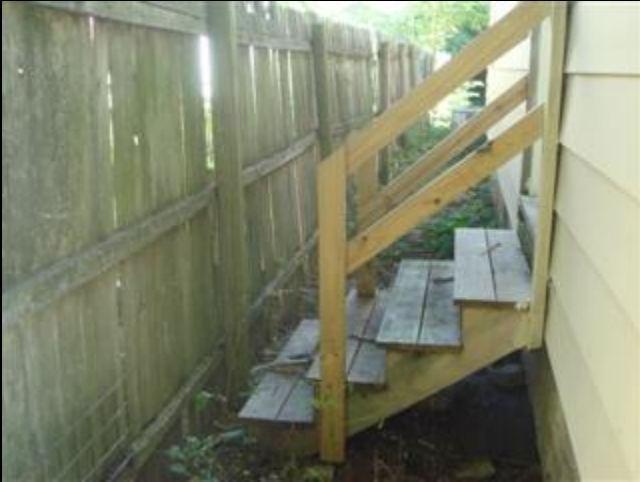
2.4 Picture 2

🏠 2.4 (2) No sufficient room between bottom of stairs and fence. May want to consider a landing with stairs going in either north or south direction.

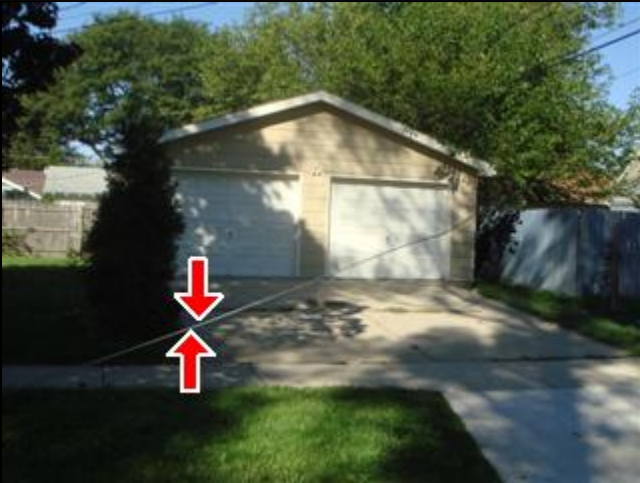
2.5 Picture 1

🏠 2.5 (1) Guide line running down from electric pole not giving proper clearance over driveway. Recommend contacting electric company to have it corrected.

(1) Guide line running down from electric pole not giving proper clearance over driveway. Recommend contacting electric company to have it corrected.
-

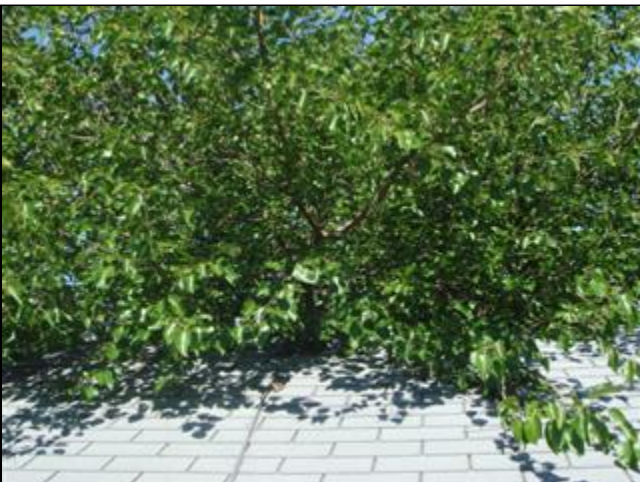
2.5 Picture 2

🏠 2.5 (2) The tree limbs that are in contact with roof or hanging near roof should be trimmed.

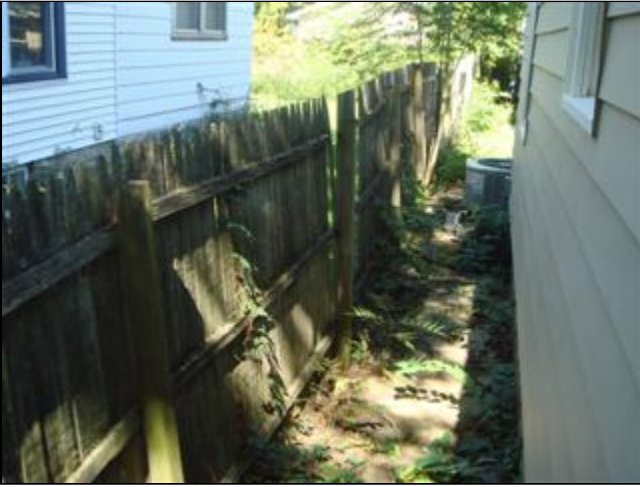
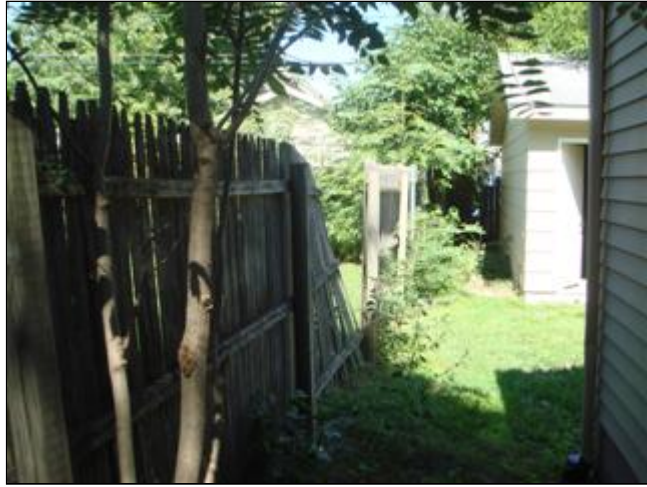
2.6 Picture 1

**2.6** Fence needs repair. Recommend repair by a qualified contractor.

Fence needs repair. Recommend repair by a qualified contractor.

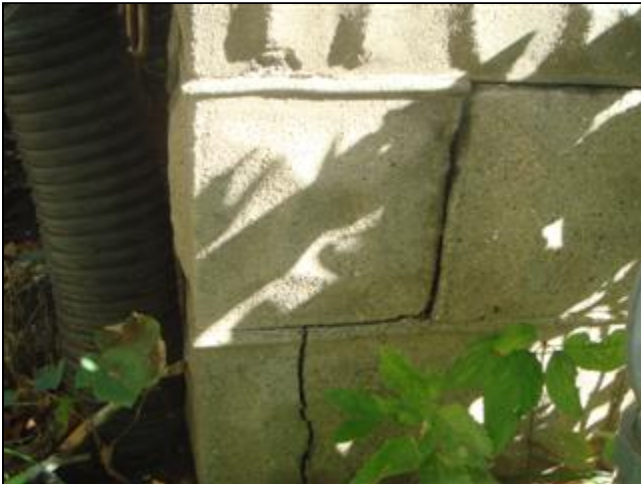
3.0 Picture 1

**3.0** (1) Crack observed at corner of house. recommend sealing to keep out moisture and prevent further cracking.

(1) Crack observed at corner of house. recommend sealing to keep out moisture and prevent further cracking.
-

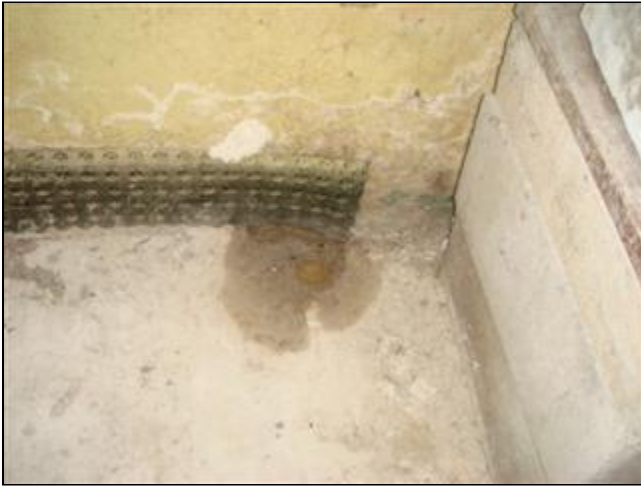
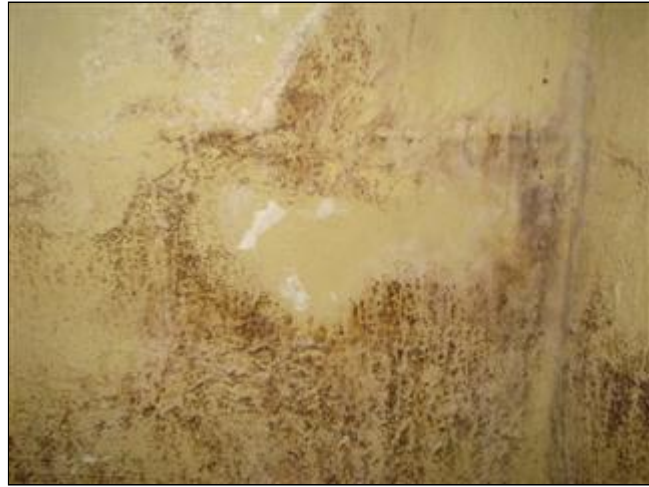
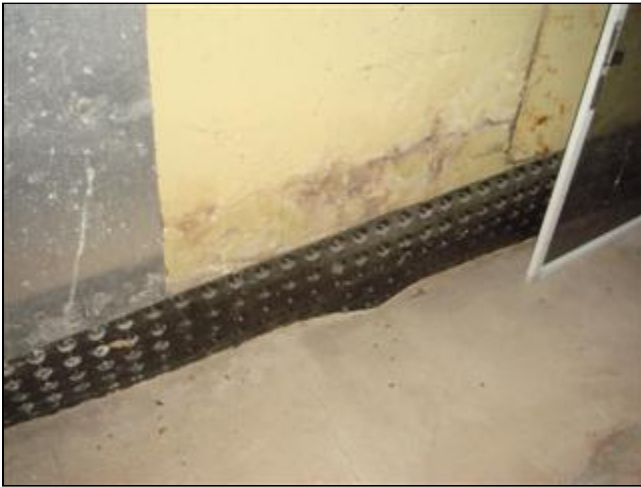
3.0 Picture 2

**3.0 (2)** Visible signs of water intrusion in the basement are present from water stains and a mold like substance on wall. The existing sump pump does not appear to be adequate in removing the moisture and additional correction is needed. I recommend further investigation or correction by a qualified licensed contractor or water infiltration specialist.

(2) Visible signs of water intrusion in the basement are present from water stains and a mold like substance on wall. The existing sump pump does not appear to be adequate in removing the moisture and additional correction is needed. I recommend further investigation or correction by a qualified licensed contractor or water infiltration specialist.

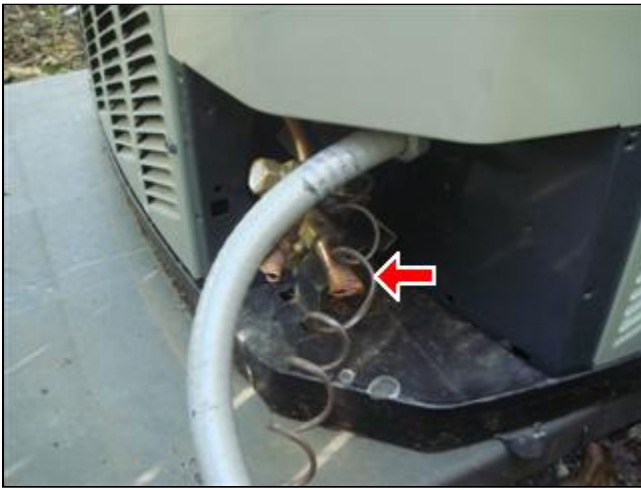
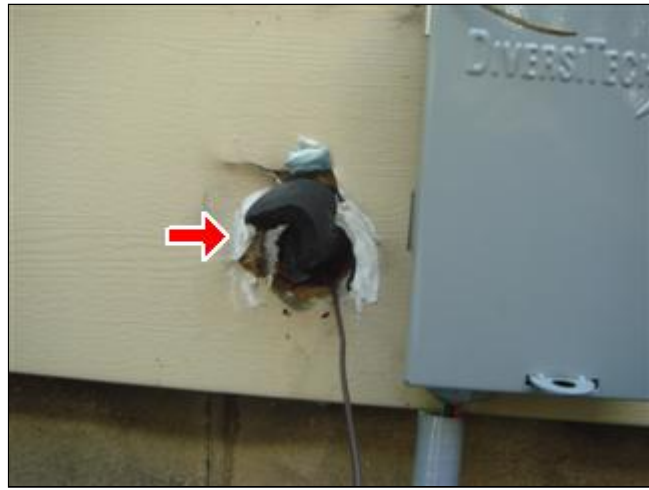
4.6 Picture 1

**4.6** The line set from the AC unit was Sawn off. Recommend repair by a qualified HVAC contractor.

**4.7** Due to the line set missing from the AC unit. Was unable to test the AC unit.

The line set from the AC unit was Sawed off. Recommend repair by a qualified HVAC contractor.

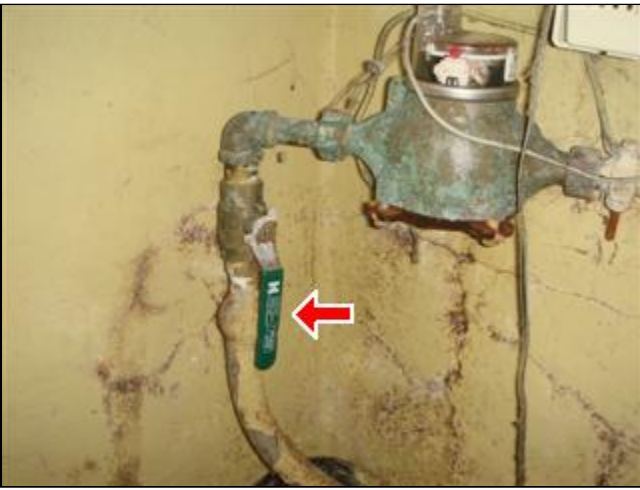
5.0 Picture 1

5.0 The main shut off is the green lever located in the basement. This is for your information.

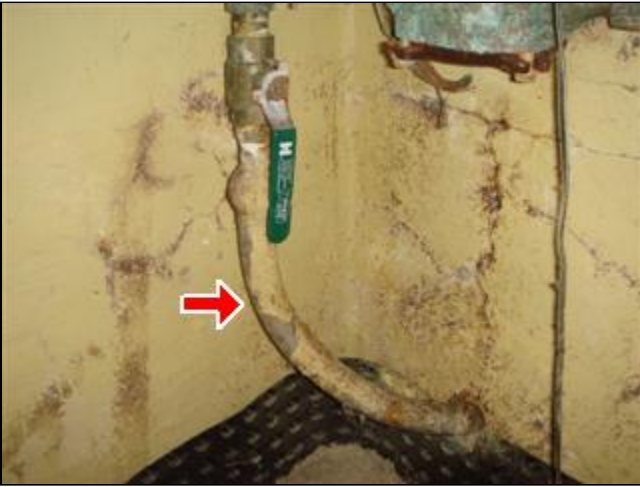
5.1 Picture 1

5.1 (1) Entry water supply pipe is lead pipe. Recommend water be tested and take necessary action if high levels of lead found.

(1) Entry water supply pipe is lead pipe. Recommend water be tested and take necessary action if high levels of lead found.
-

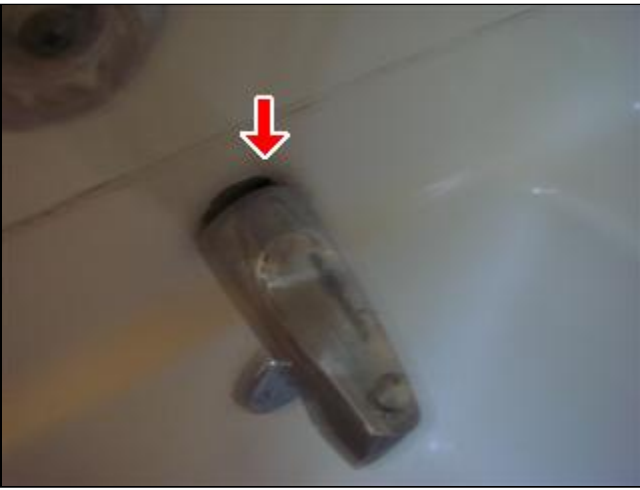
5.1 Picture 2

5.1 (4) The tub faucet is not tight against the wall. A qualified licensed plumber should repair.

(4) The tub faucet is not tight against the wall. A qualified licensed plumber should repair.

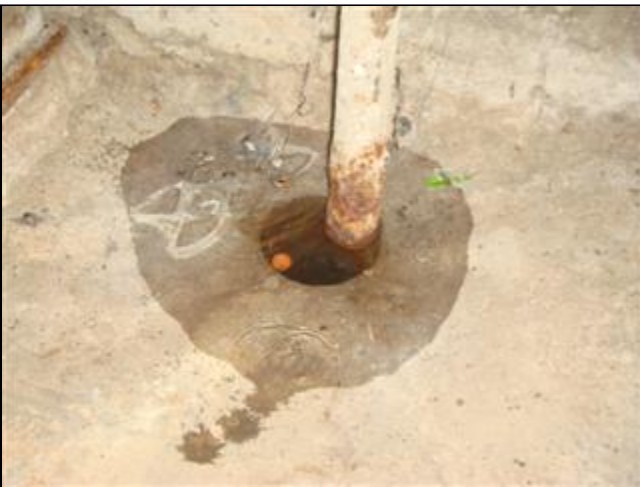
5.2 Picture 1

5.2 (2) Floor drain did not drain well. Recommend repair by a qualified plumber.

(2) Floor drain did not drain well. Recommend repair by a qualified plumber.
-

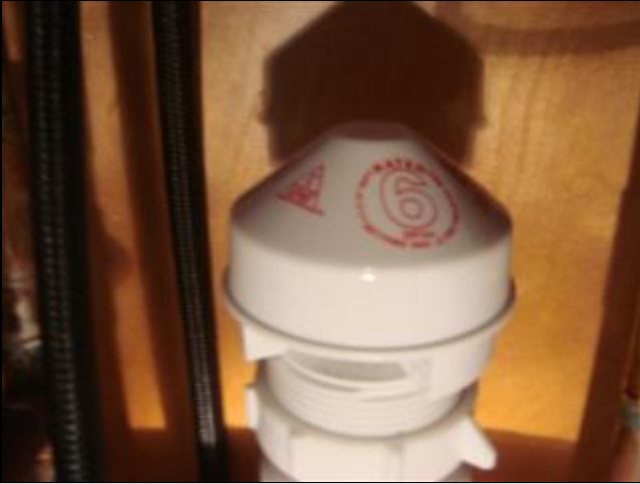
5.2 Picture 2

5.2 (3) Air admittance valves are prohibited in Illinois. One was found under kitchen sink. Recommend a qualified plumber correct this.

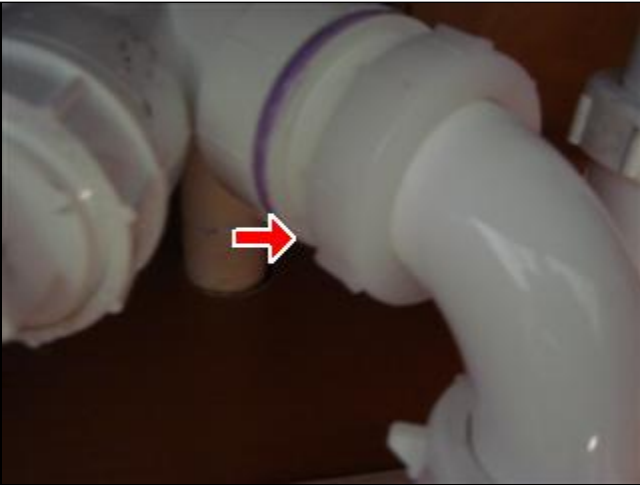
5.2 Picture 3

5.2 (4) Drain leaked under kitchen sink. Recommend a qualified plumber repair.

(4) Drain leaked under kitchen sink. Recommend a qualified plumber repair.

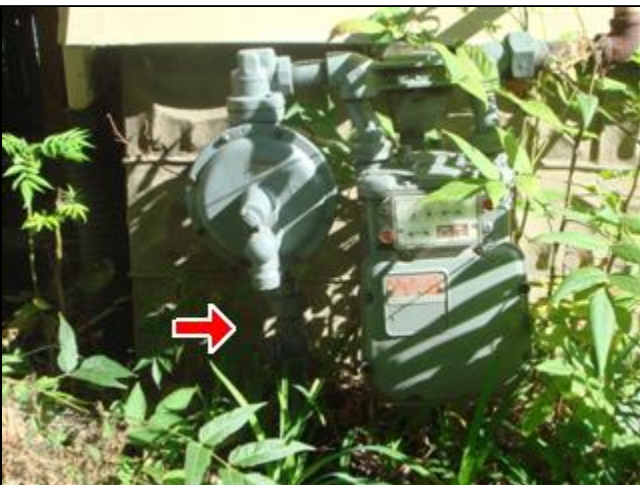
5.3 Picture 1

5.3 The main fuel shut off is at gas meter outside

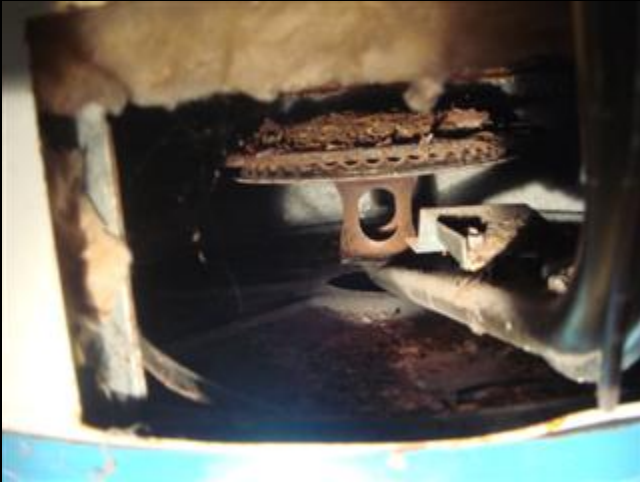
5.5 Picture 1

5.5 Hot water heater was not operational. Burner chamber rusted and full of debris. Water heater appears near end of life expectancy. Recommend evaluation and repair by a qualified plumber.

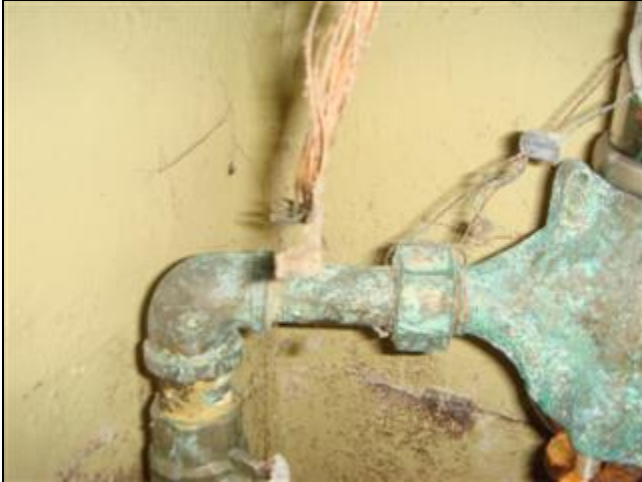
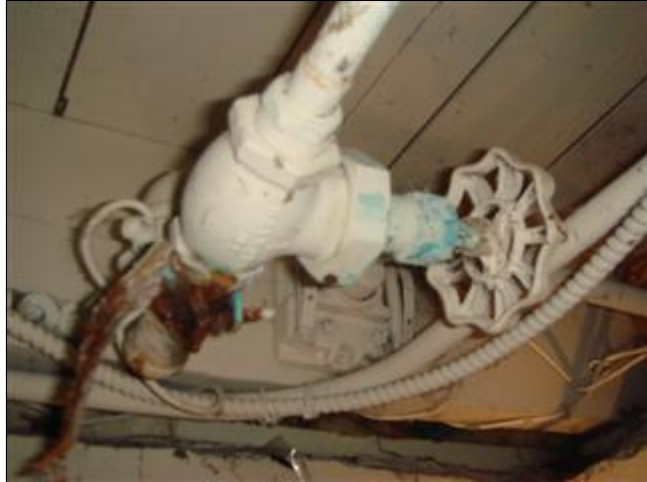
6.1 Picture 1

📌 6.1 (1) The grounding wire is attached to water pipe far from where the water pipe enters the house and the bond strap around the water meter is unattached. Recommend repair by a qualified electrician.

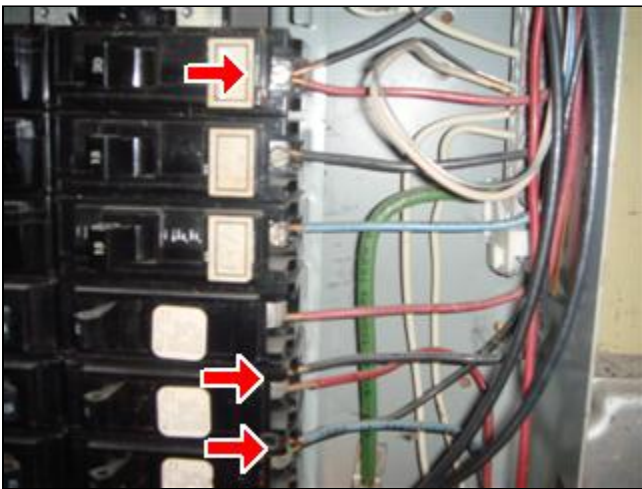
6.1 Picture 3

📌 6.1 (2) The problem(s) discovered in the panel such as doubled wiring at circuit(s), and any other problems that an electrician may discover while performing repairs need correcting. I recommend a licensed electrician inspect further and correct as needed.

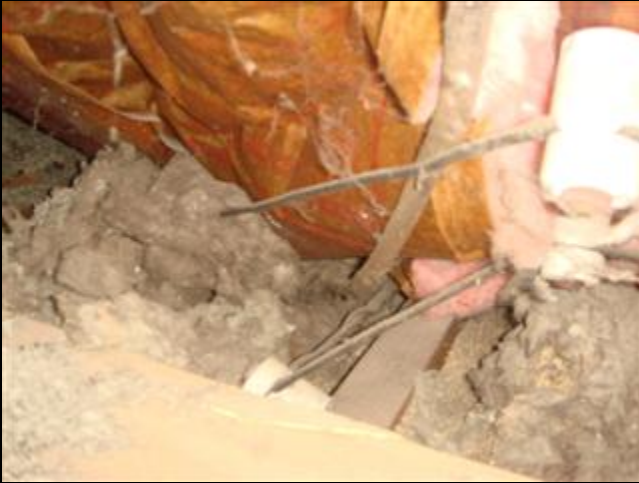
6.2 Picture 1

6.2 This property has some "knob and tube" wiring, which was commonly installed prior to 1950. It is ungrounded, and considered unsafe by today's standards. Over time, the wire's insulation may become brittle and fall apart or wear thin, resulting in exposed conductors and a risk of shock and/or fire. This wiring is also easily damaged by covering it with insulation (a common practice), and incorrectly tapping new wiring into it.

Some energized knob and tube wiring was found during the inspection. It is not within the scope of this inspection to determine what percentage of this property's wiring is of the knob and tube type, or to determine what percentage of the knob and tube wiring is energized vs. abandoned. A qualified electrician should evaluate this wiring and make repairs or replace wiring as necessary.

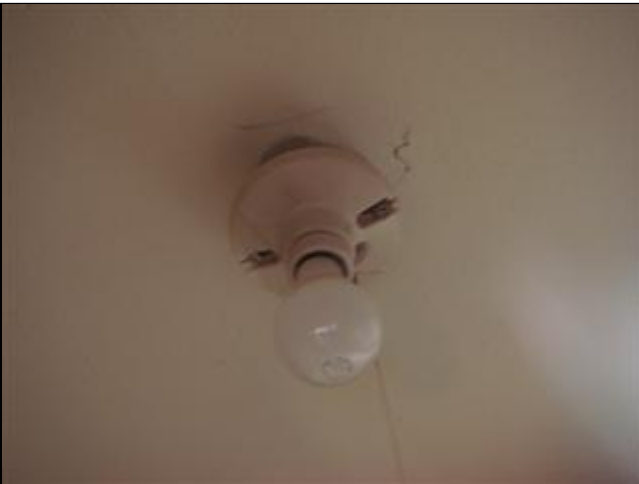
6.3 Picture 1

6.3 (1) The light fixture is missing globe at the closet. This is a safety issue that needs to be corrected. I recommend repair as needed.

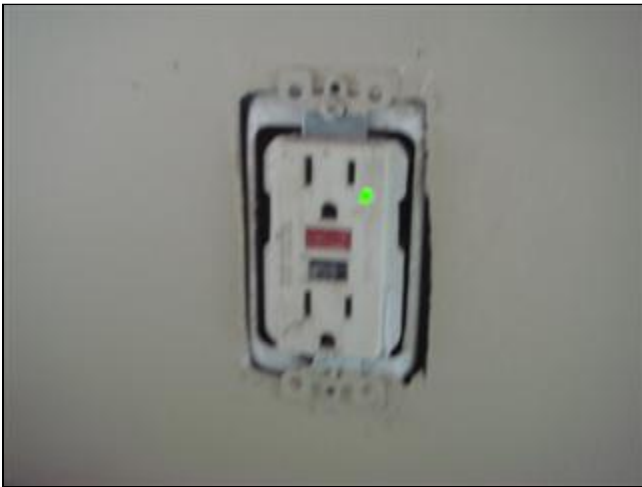
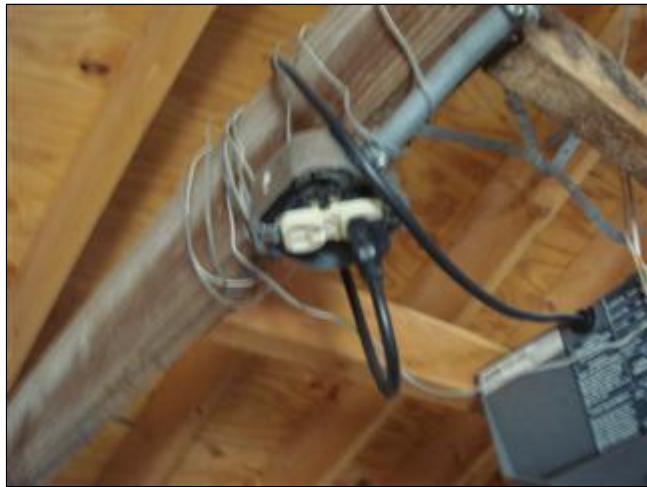
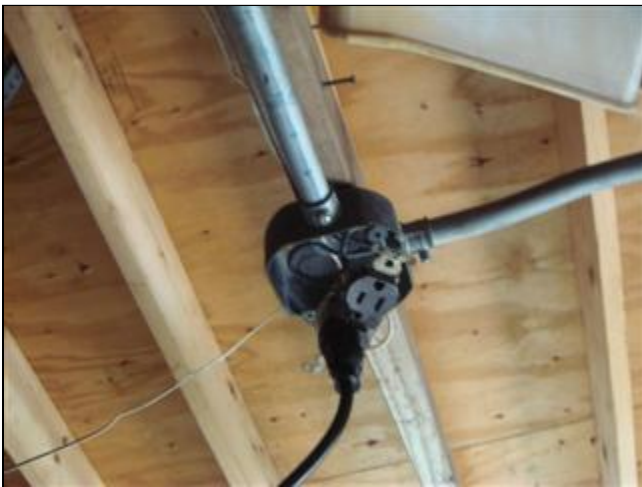
6.3 Picture 2

6.3 (2) Missing receptacle cover plates. Recommend repair.

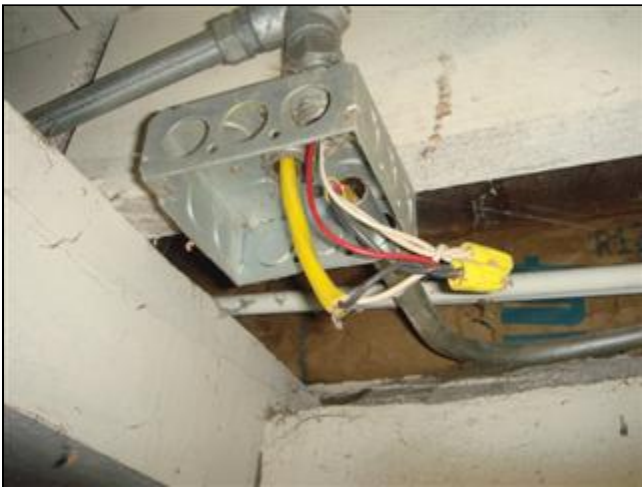
6.3 Picture 5

6.3 (3) Exposed wiring. Junction box should have a cover plate. Recommend repair.

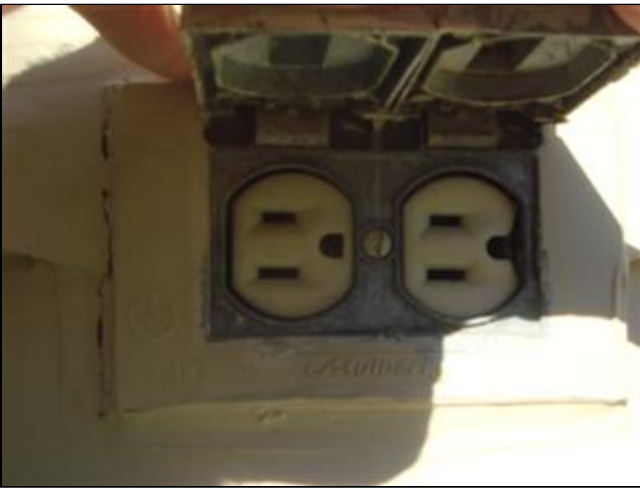
6.4 Picture 1

6.4 (1) Outside receptacle and receptacle in garage should be GFCI. Recommend repair by a qualified electrician.

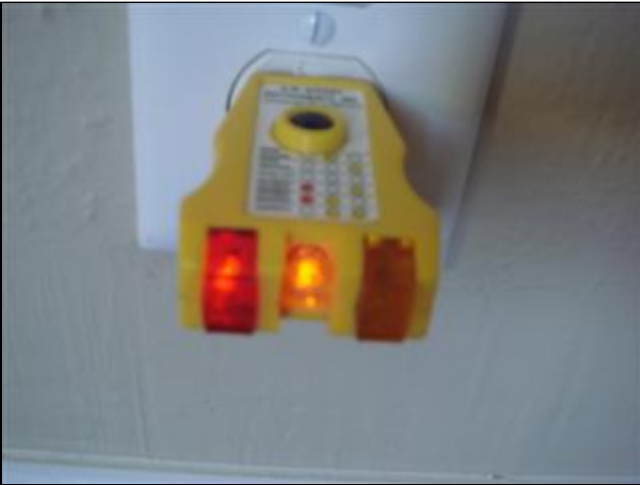
6.4 Picture 2

6.4 (2) Some hot/neutral reversed receptacles and many ungrounded receptacles. Recommend repair by a qualified electrician.

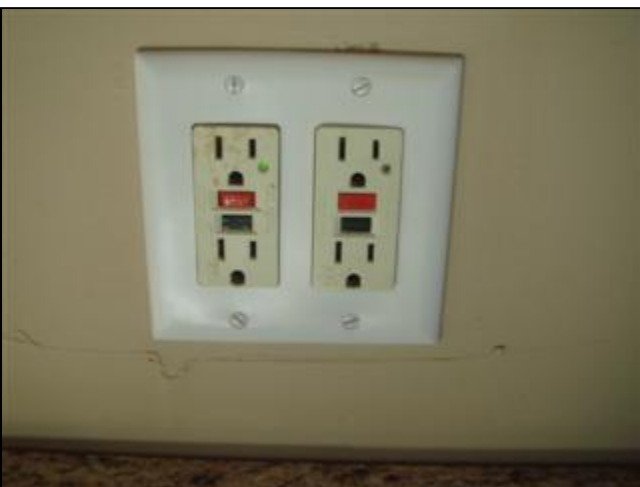
6.5 Picture 1

6.5 Kitchen GFCI receptacles did not trip when tested. Recommend repair by a qualified electrician.

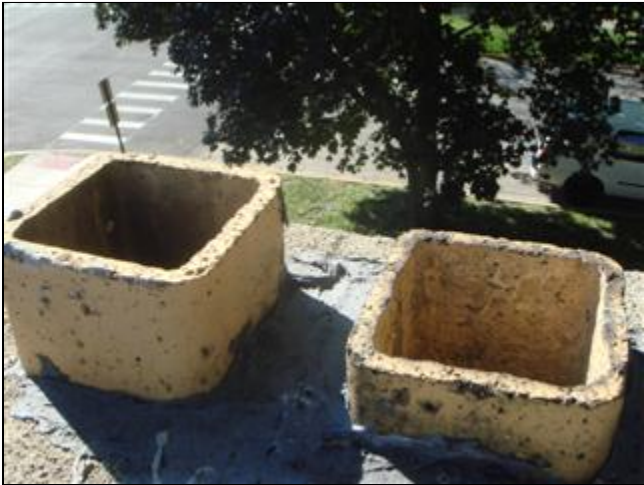
7.0 Picture 1

**7.0 (2)** Recommend chimney caps be installed.

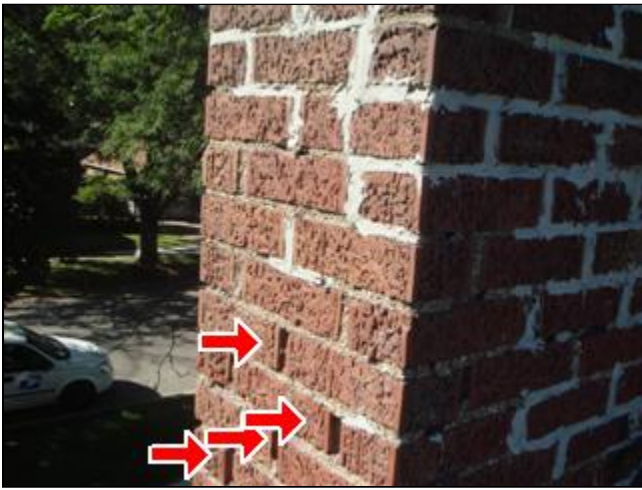
7.0 Picture 2

7.0 (3) Tuck pointing needed on chimney. Recommend repair by a qualified contractor.

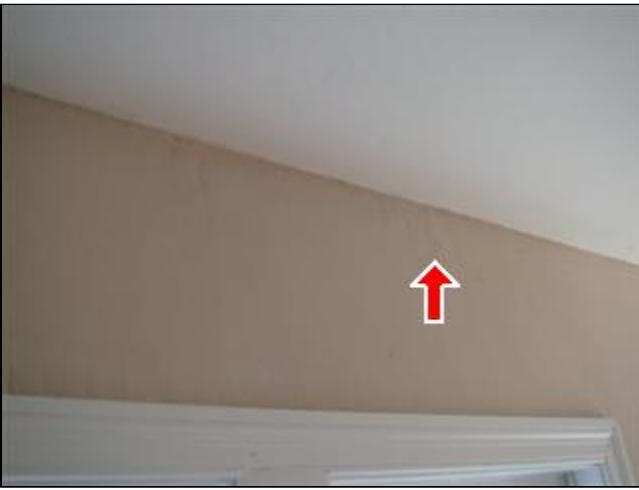
8.1 Picture 1

8.1 Some moisture intrusion observed.

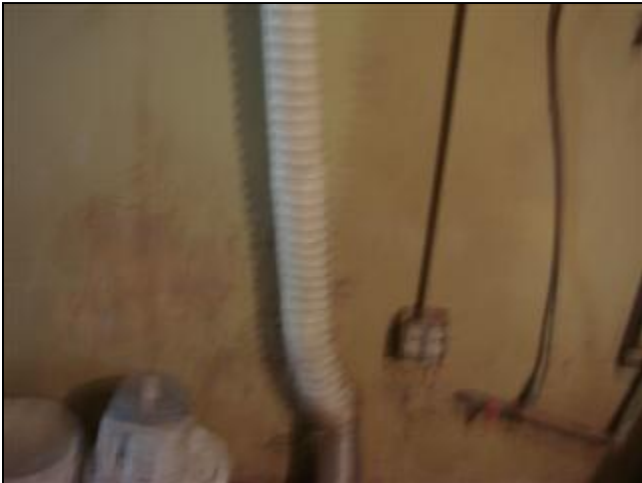
9.3 Picture 1

9.3 The plastic vinyl is not an approve ducting material for dryers. It should be replaced with rigid or corrugated semi-rigid metal duct. This is a safety issue and should be replaced.

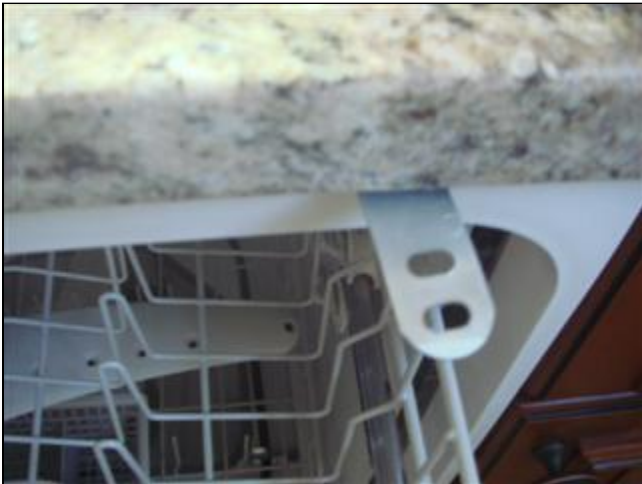
11.0 Picture 1

**11.0** (1) The dishwasher was not secured to the counter. Recommend repair.

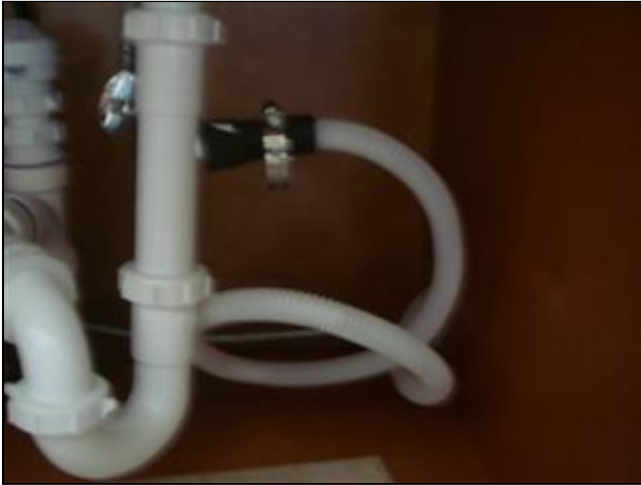
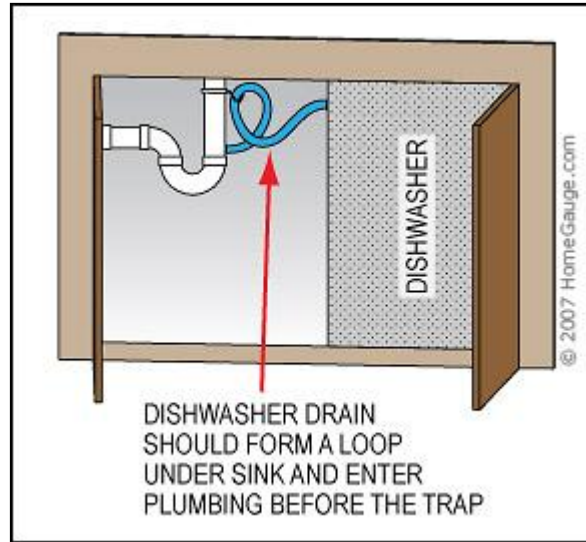
11.0 Picture 2

11.0 (2) Recommend that the dishwasher drain be re-installed so as to provide for a high loop, where the dishwasher drain pipe is secured to the underside of the base cabinet countertop and looped so that the loop is at the "flood level" of the sink drain. This will guard against water back flowing from the drain into the dishwasher and guard against contamination of the dishes with drain waste water.
